Project Profile

Olympia Medical Center
Olympia, Washington

Adhered EnergySmart Roof using
72 mil Sarnafil® G410 membrane
in white

Sika Sarnafil System Keeps Medical Center Up to Snuff

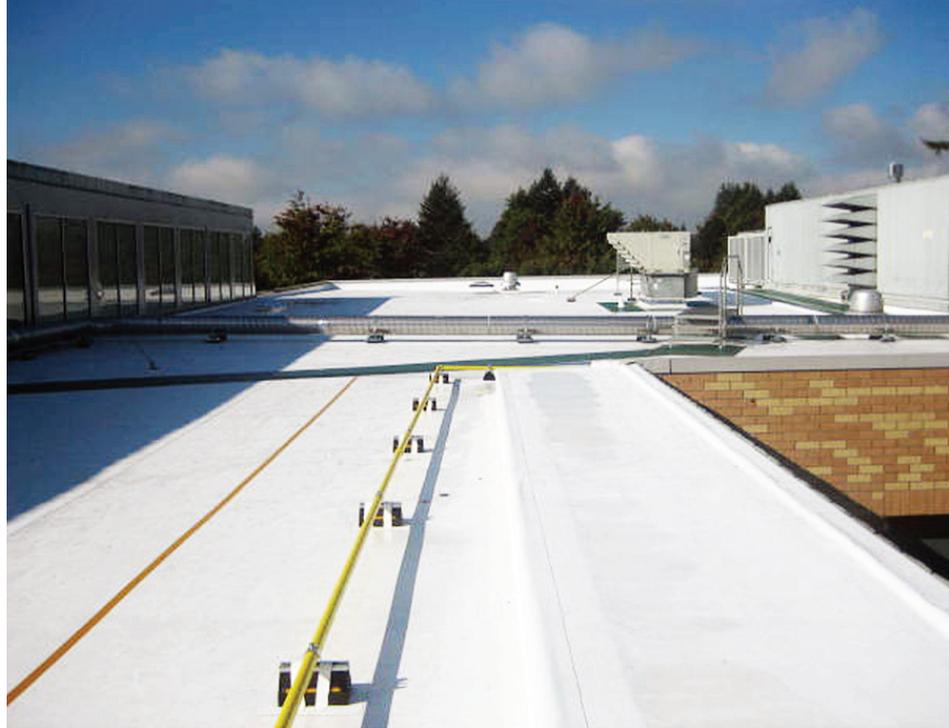
There were, however, a few areas where the roof installation was very challenging – especially under the three, 50-foot air handlers with sleepers (risers or curbs that elevated the air handlers off the roof) that were 30-feet long and eight-feet wide. "When we installed the new roof we increased the insulation thickness, which made it a real challenge to install the new roofing system under the air handlers," Anderson stated. "In some places we only had three to four inches of clearance between the top of the sleeper and the roof."

effective solution: they jacked up the air handlers just enough to remove the sleeper covers and old roofing system and install the vapor barrier and insulation; and then they took one 10-foot-wide sheet of the Sika Sarnafil membrane and slid it up and over the sleepers at each of the air handlers. This way the edges of the sheets could be welded to the outside edges, eliminating any welding underneath the air handlers.
